Aesthetic repairs secure cracked masonry arch

Client & Engineers: Cumbria County Council

Location: Cleator Moor, Nr. Whitehaven

Installers: Corecut

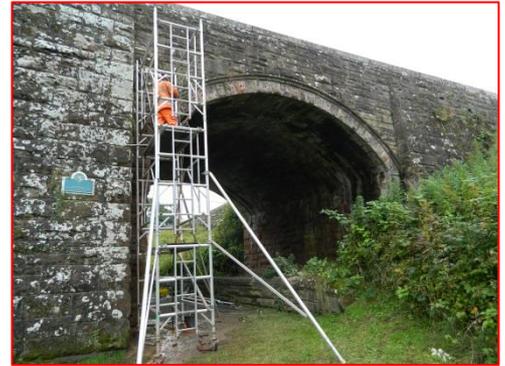
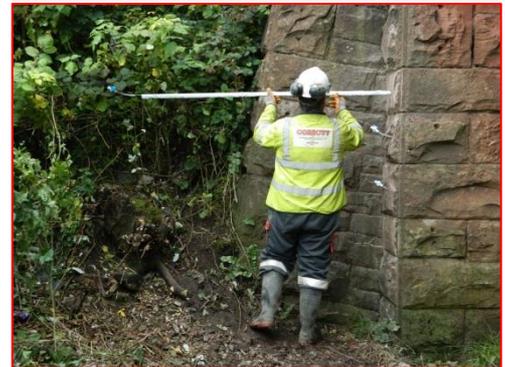
As this part of Cumbria is very prone to flooding the second arch provides a useful outlet for flood water but was suffering from circumferential cracking of the barrel soffit and crown. This was as a direct result of differential movement between the stiff parapet sections and the masonry barrel arch.

Council engineers designed the repair to stabilise the cracked barrel soffit using a mixture of 2m, 2.5m and 3m SockFix grouted anchors installed through the voussoirs on both sides of the arch.

- Sockfix use diamond-cored holes, with very little vibration passed to the weak substrate, and the drilled core was retained to conceal the installed anchors.
- The injection of grout under very low pressure meant installation was very gentle on the surrounding masonry and possible voids did not impede installation or effectiveness of the anchors, maximising their bond between the internal and external leaves.
- There was virtually no grout seepage and the retention of the core was used to plug the very rough surfaced stonework leading to a very aesthetic repair.
- Once the 52 anchors had cured sufficiently, the grout tubes were cut off below the face of the stonework ready for the replacement of the colour matched core.

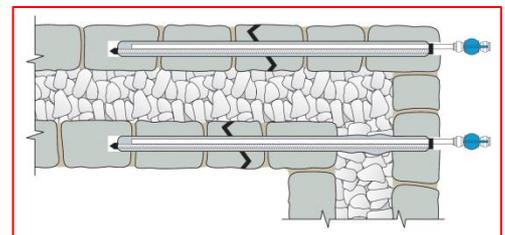
With the fully concealed repair completed, structural integrity was restored to the arch with its visual appearance unaffected.
