# HELIFIX

## Structural Preparations for Window Replacement and External Wall Insulation Programmes

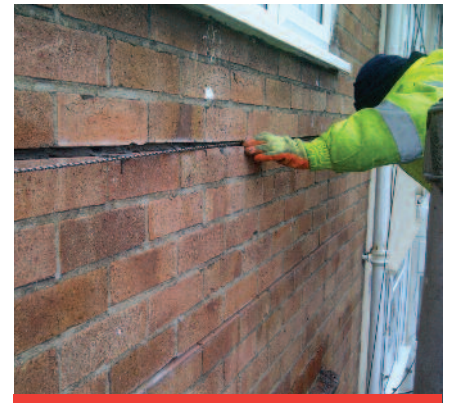
The Helifix Helibeam System overcomes all these difficulties by using the existing masonry. It is quick, simple, reliable, economical and non-disruptive. Mortar beds are channelled-out at two levels above each window and pairs of stainless steel HeliBars are bonded into the slots with HeliBond cementitious grout. A deep masonry beam is formed above the window which supports the masonry and spreads the structural loads. Generally, DryFix remedial ties or grouted CemTies are then installed vertically up through the brickwork and

into the new masonry beam to secure the existing lintel. No mechanical supports are required and the existing window frame can be removed and replaced without fear of the masonry moving.

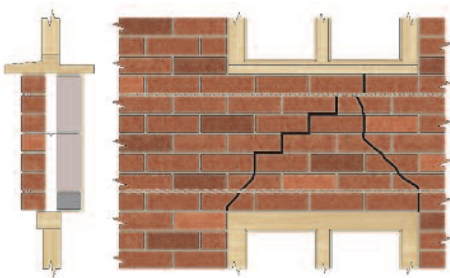
Creating lintels in a cavity wall

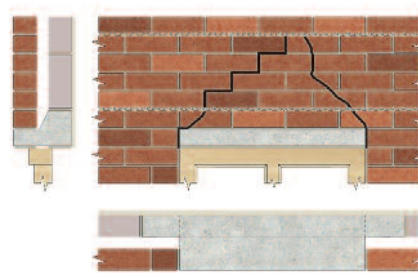
Overcoming rotating boot lintels

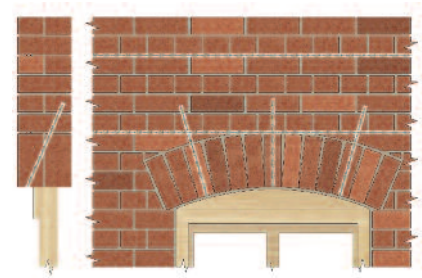
Reinstating failed brick arch lintels

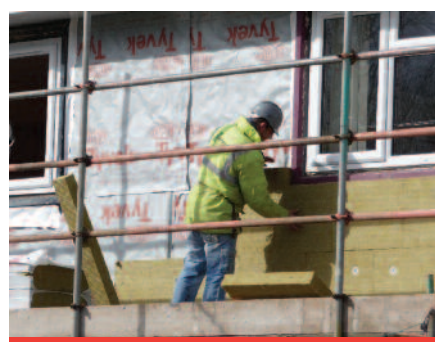
# Meeting the load requirements of external insulation panels

regulations and improving the living standards of their tenants. Where those homes are solid wall properties, prefabricated houses or precast concrete high rise buildings with narrow cavities, the use of rendered external insulation panels is popular and can improve the thermal U value of the walls by some 75%.

However, if the external elevations are unable to support the additional load of the new insulation and decorative finish due to weak, corroded or insufficient wall ties, these must be replaced or supplemented with new ties. If the inner skin or piers are constructed from clinker

Helifix one-piece, helical stainless steel remedial ties are able to satisfy these varied conditions and provide property owners with a rapid cost-effective solution. Frequently the DryFix tie is appropriate, which is rapidly installed using a special tool to power-drive the tie into both leaves via a small pilot hole, which is easily disguised. It requires no grouts, resins or mechanical expansion so can be load-tested immediately to establish its suitability. The requirements of the engineer, contractor and property owner are all satisfied, quickly and economically.

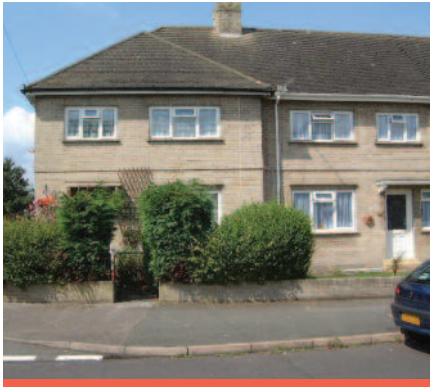
### Runnymede Borough Council, Surrey

Following a window replacement programme four years earlier, these calcium silicate brick council houses were suffering from masonry shrinkage and cracking and sagging of the lintels above the windows.

The Helifix method required no taking down and rebuilding or steel lintels, was much quicker and caused minimal disruption. Furthermore, the average cost was £3,000 on 87 houses – a saving of nearly £1.5m. Indemnified warranties were provided to the client.

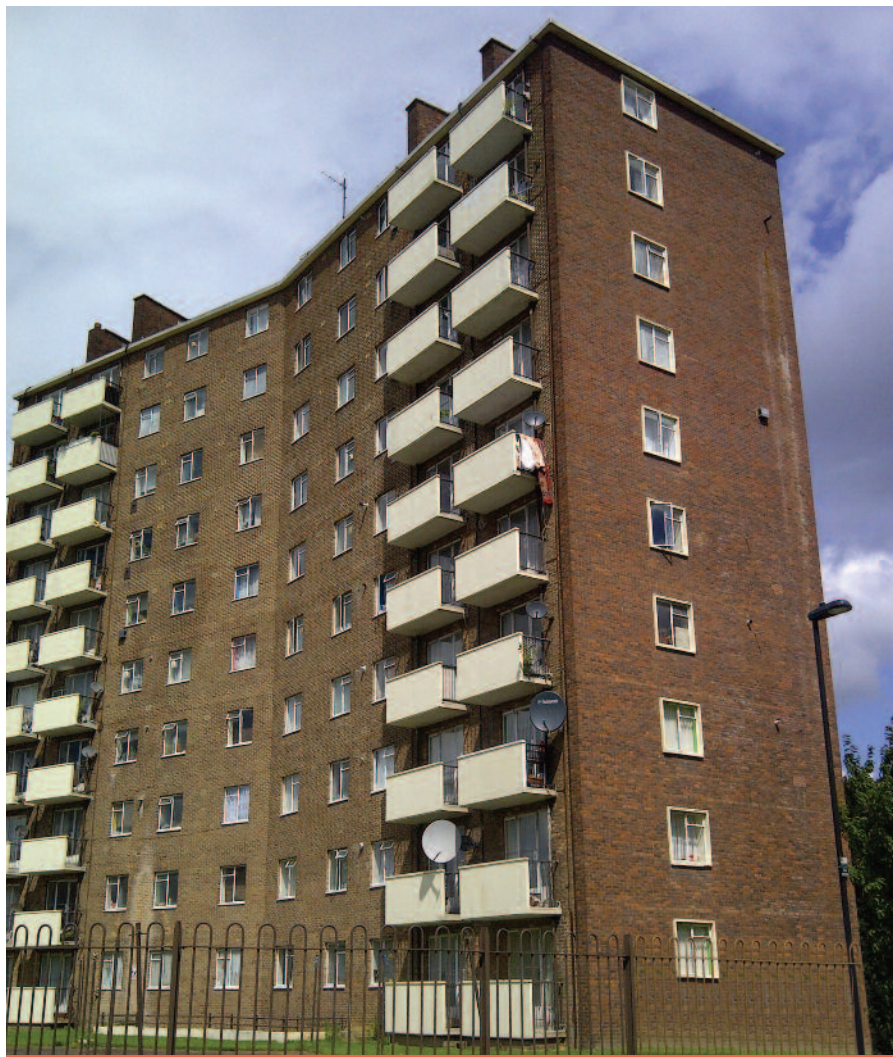
### London Borough of Haringey

At Trulock Court, a 10 storey 'Y' shaped residential tower block, the masonry above each opening was only supported by the existing load bearing metal windows and there was also a serious lack of wall ties.

The Helifix system avoided the difficulty and expense of using temporary mechanical supports and the installation of new concrete lintels. It was much quicker and more economical, enabling the window replacement and remedial wall tie programmes to be completed in just three weeks. Also, it had no effect on the building's appearance.

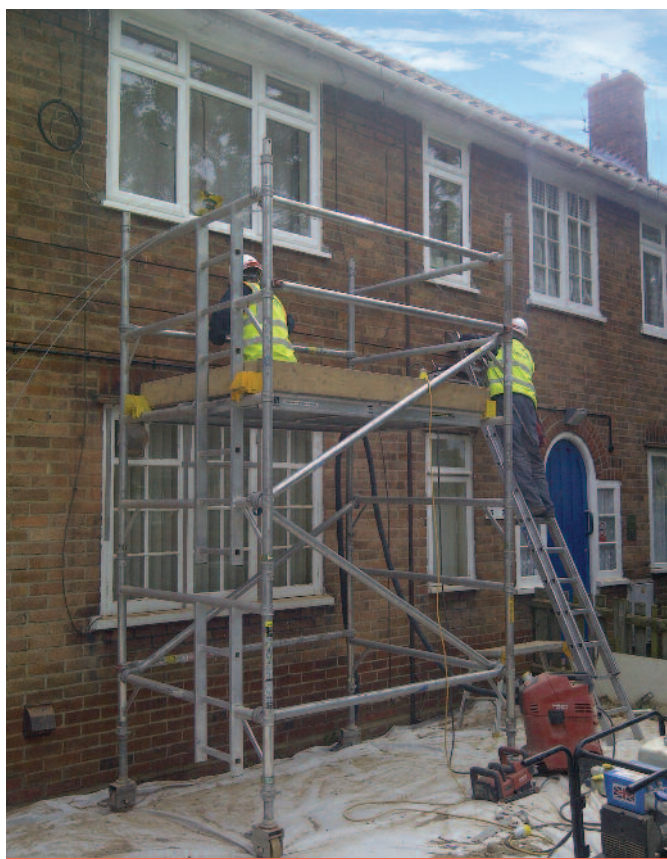
## Norwich City Council

Before beginning a major window replacement programme on numerous council properties, surveys indicated that masonry above the soldier course header bricks could move once the existing frames were removed, making installation of the new frames extremely difficult. Major failures had been experienced before commencing installation of the Helifix system from Helifix.

Furthermore, it was cost-effective, caused minimal disruption and the work was covered by a Helifix warranty for the products and installation, undertaken by an Approved Installer, as well as third party insurance with the Consumer Protection Association.

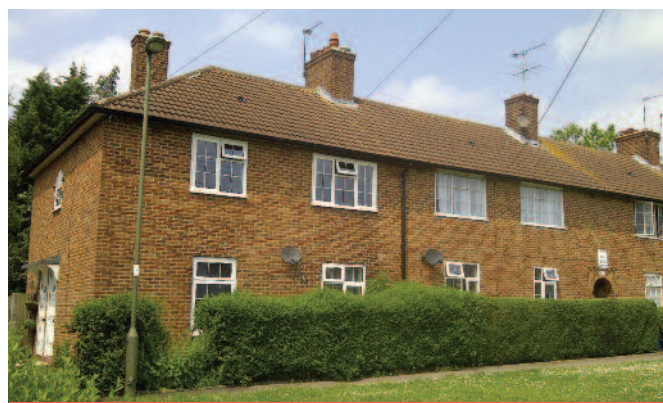
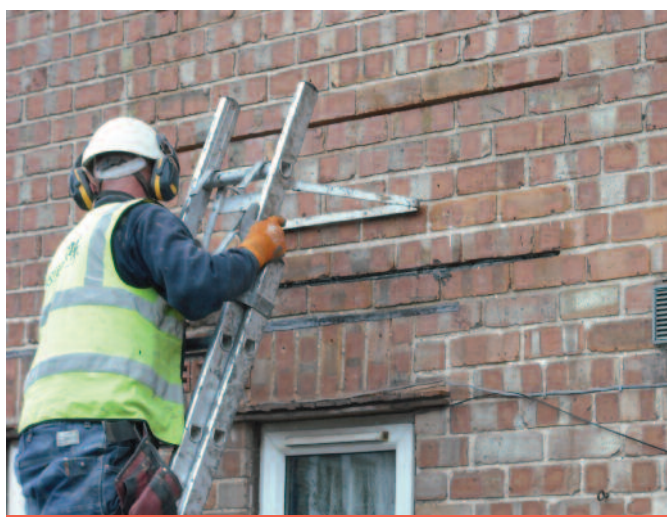
## Sanctuary Housing, Scarborough

Many of these housing association properties, which were due for window replacement, had inadequate outer leaf support above the windows. Additional reinforcement was required to avoid any movement of the masonry above the openings once the existing window frames had been removed.

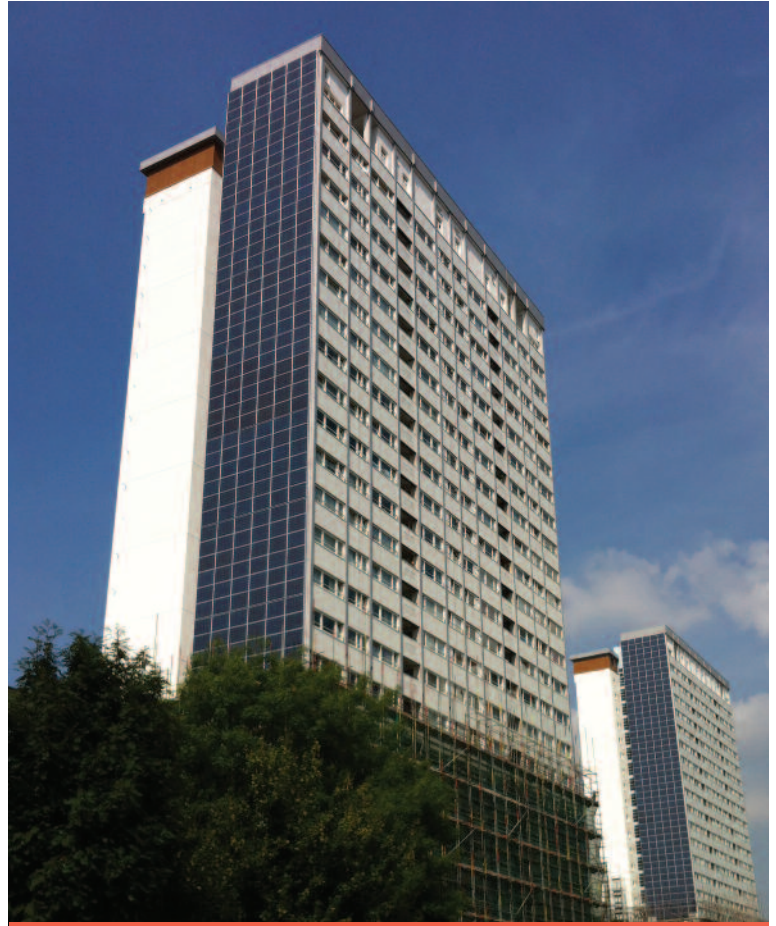
### London Borough of Hammersmith & Fulham

The structures comprise a concrete frame, lightweight concrete block infill and a brick outer skin. Project engineers, Carter Clack, chose Helifix to undertake reinforcement of the calcium silicate brickwork in stairwells on all three blocks to ensure these areas were strong enough to take the weight of the external over-cladding system and render.

An innovative technique, involving interlocking 23,000 bonded ResiTies and 15,000m of HeliBars in the six stairwells, connected the inner leaf to the main structure and enabled the HeliBars to distribute the wall tie loads through the entire face of the outer leaf masonry, providing greater resistance to wind loadings. Once the stairwell masonry had been fully secured, connected and reinforced, the external cladding and rendering of the towers could proceed.

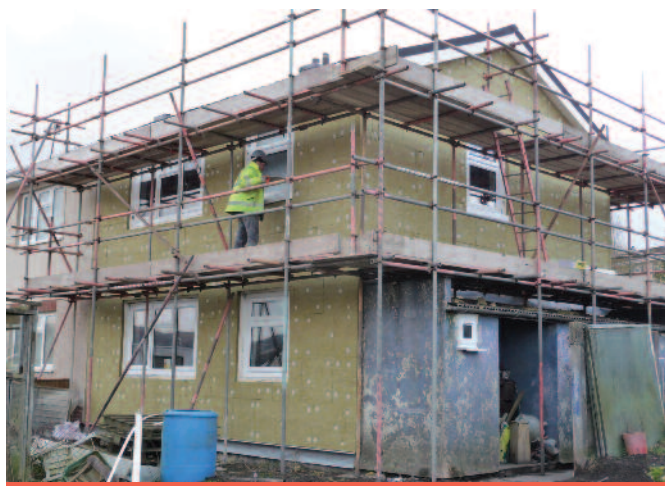
### RCT Homes, Penywaun, South Wales

Constructed with a clinker block internal skin, a concrete external skin and just a 50mm cavity, 170 properties owned by the largest social landlord in Wales were to be upgraded to meet current thermal insulation requirements.

Engineers determined that the strength of the external walls needed increasing in order to bear the weight of the new external cladding system. They stated that the new wall ties must have an enhanced minimum pull-out of 1.6kN while the contractor wanted ties that could be rapidly and easily installed as the contract was on a tight timescale.

Following on-site testing, DryFix remedial ties were specified as they satisfied all the requirements. Installation was rapid and trouble-free and the project was able to remain on schedule.
